Resilience to hurricanes in the building sector in Antigua and Barbuda

Building assessment final report 2 July 2019

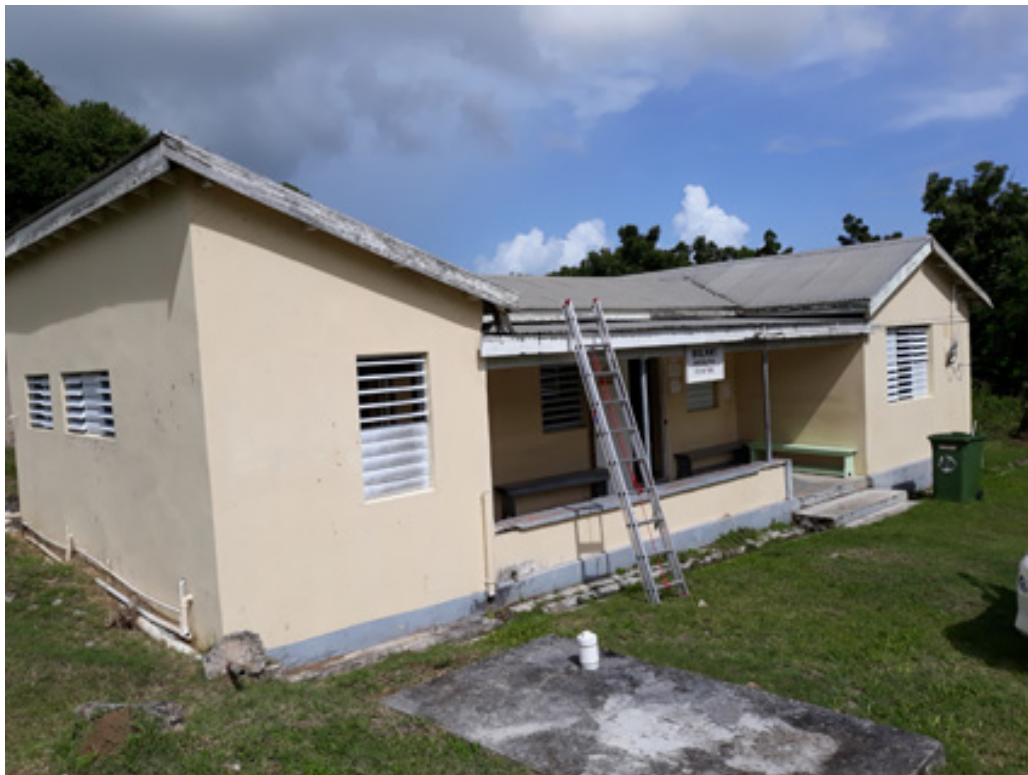
Bolans health clinic

A typical small building of mortar block construction

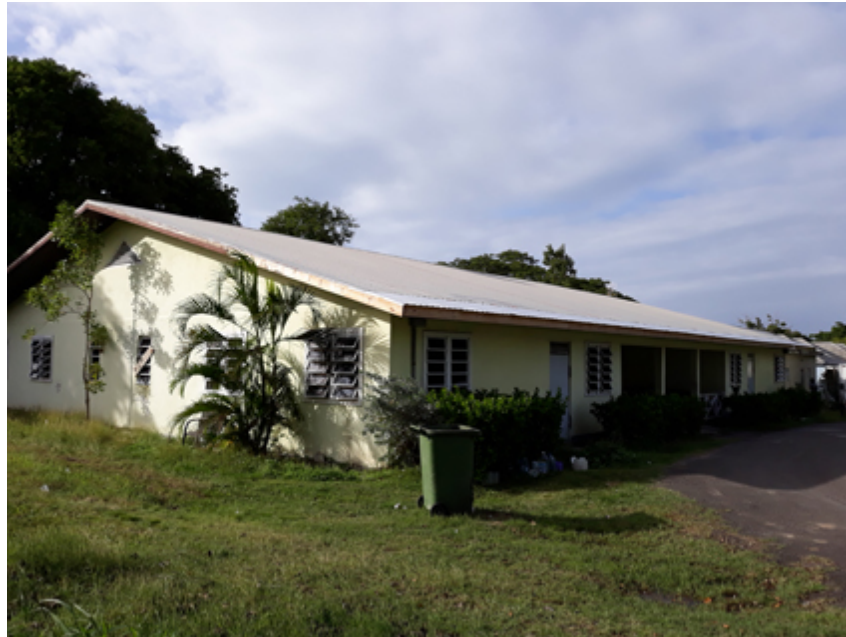
Clearvue psychiatric hospital

Note the typical wood framed and sheet metal pitched roof

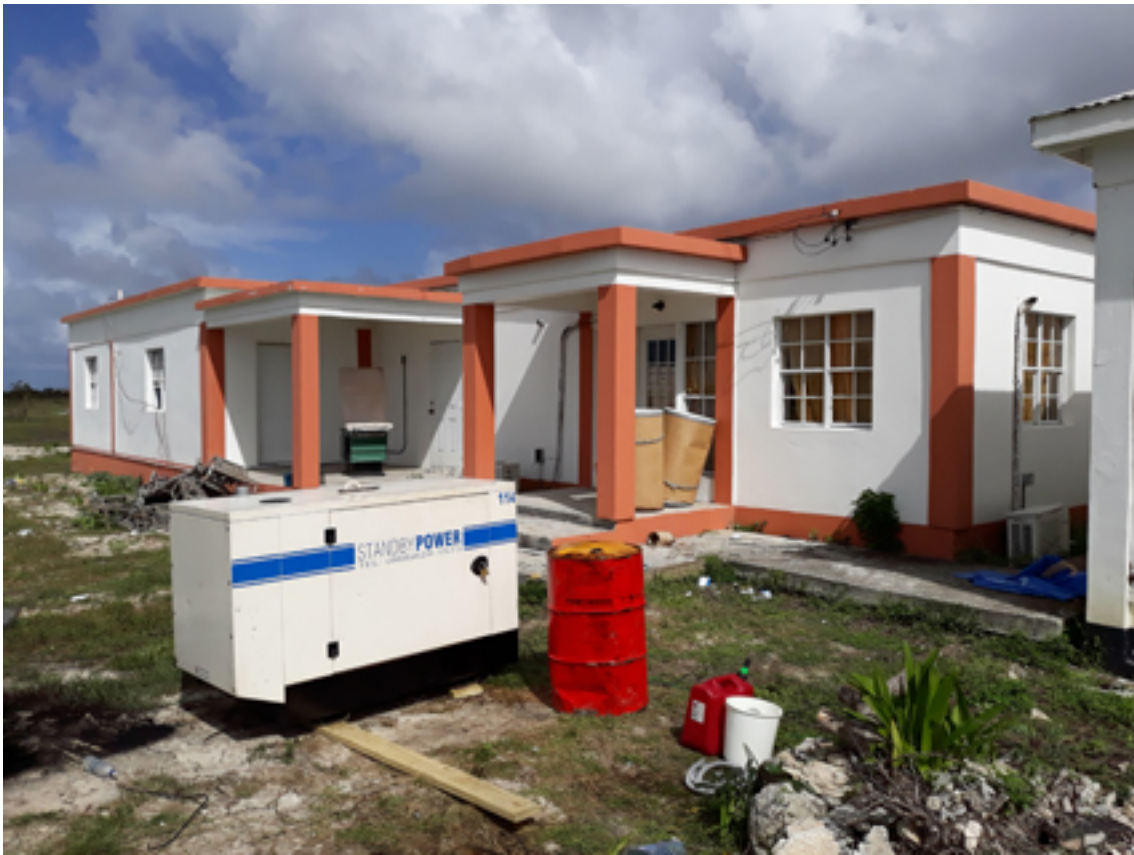
Barbuda hospital

Concrete construction including reinforced concrete roofing

Note that concrete degradation was noted in all but the most recent buildings. The most common problem noted was water infiltration via exposed reinforcing and poor quality casts. This in turn results in reinforcement corrosion and expansion and concrete spalling.

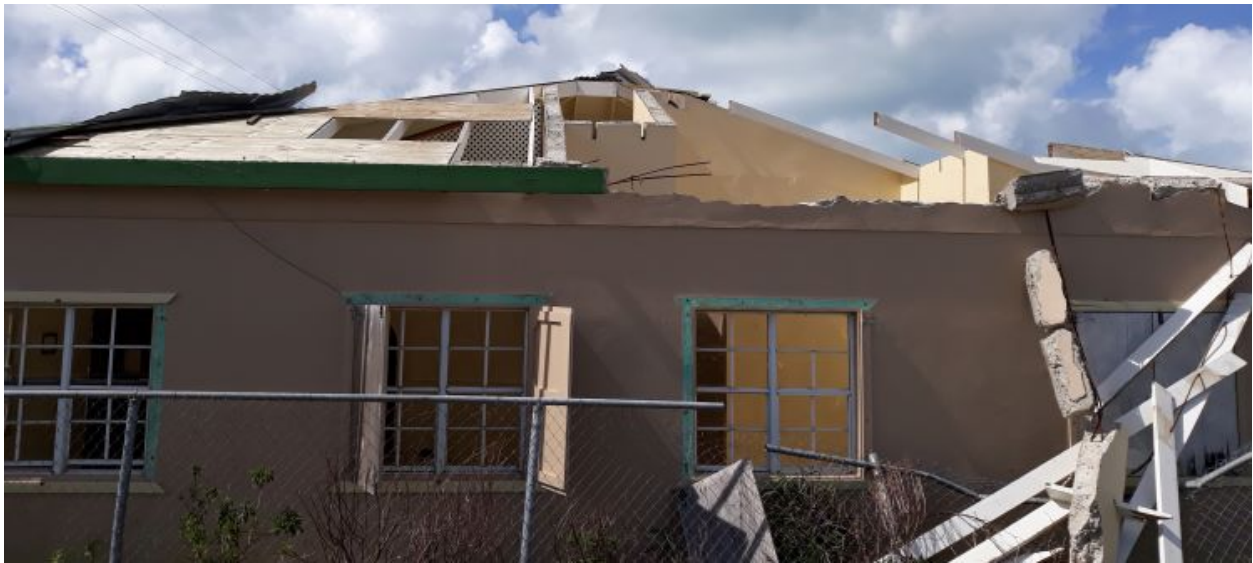
Barbuda fire station, showing multiple modes of roof failure

- Short term flash flooding and standing water caused widespread damage in all areas, particularly to building contents.
- All of the anticipated roofing failure modes were visible in the damaged buildings:
